Replacing SW20 gearshift cables

Cable differences

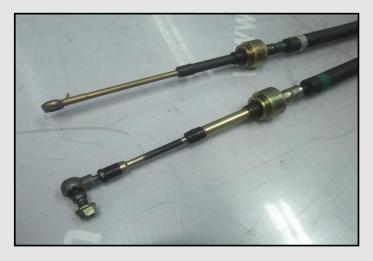
Shown above are two different SW20 gearshift cable sets showing the gearstick end.

The ones on the left that have green and white bands are used on NA models, while the ones on the right that have blue and red bands are used on Turbo models.

Apart from the markings, the difference between the two sets would appear to be in the cable length.

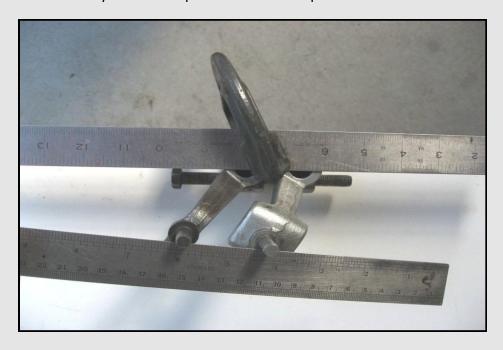
I placed a tight fitting 10 mm bolt through the cotter pin holes, thus aligning them both the same way as they are fitted to the selector shaft, and clamped a ruler parallel to the 10 mm bolt to help see the bolt's orientation.

Although the updated lever on the right has a different casting shape, the angle difference between the two rulers shows that the cable mounting pin on the updated lever is rotated slightly clockwise compared to that of the early model lever on the left.

The angle difference means that with the updated lever, the cable bush sits about 10 mm further back at the gearbox end so that a slightly longer cable is needed if the gear-stick is to sit vertical in neutral. That could explain the different cable part numbers catalogued for early and later models.

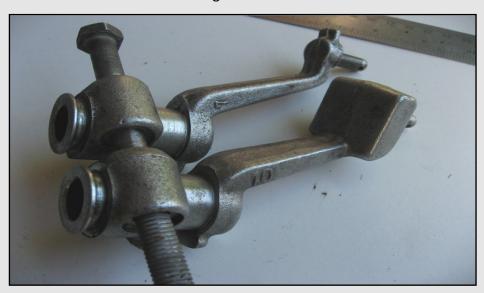
In the next pic, although I don't know what the numbers mean, you can see a 7 and a 10 cast into the two levers that I have. I assume the heavier casting behind the cable mounting pin on the updated lever is to give the end more mass to aid in smoother shifting.
